TROUBLESHOOTING Thermal Expansion Valves

Here is the correct way to diagnose and troubleshoot a system with a TXV as its flow control device.

BY AL MAIER

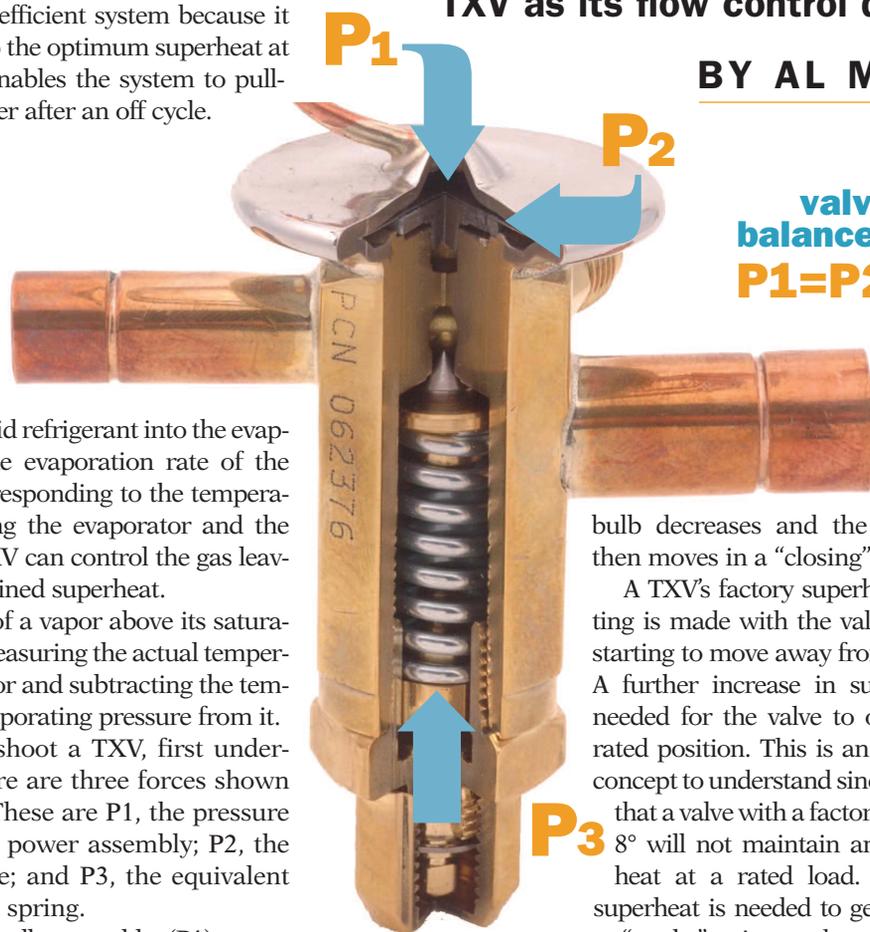
valve is in balance when $P1=P2+P3$

bulb decreases and the valve pin then moves in a "closing" direction.

In order to correctly troubleshoot a TXV, first understand how the valve works. There are three forces shown that govern a TXV's operation. These are P1, the pressure created by the remote bulb and power assembly; P2, the evaporator or equalizer pressure; and P3, the equivalent spring pressure of the superheat spring.
